C5 Evidence Project

Phase Two: Final Report

Findings prepared by Engineering New Zealand

28 September 2021

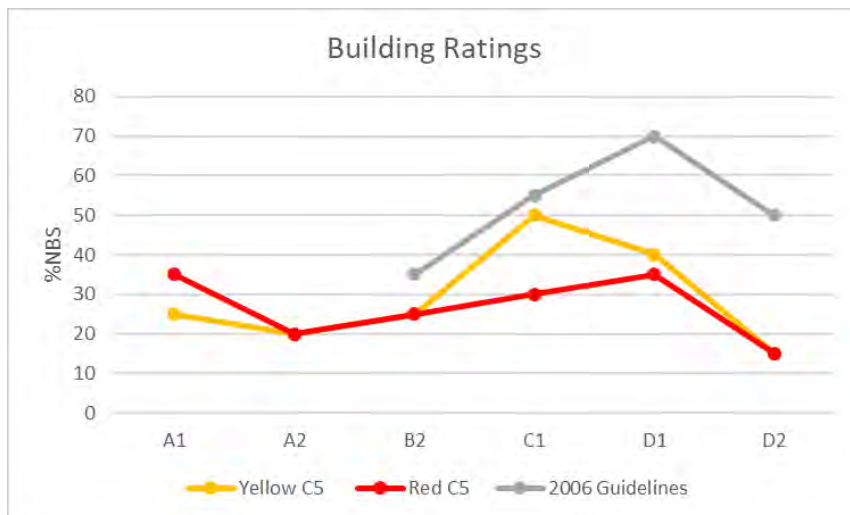
Figure A: Phase One C5 Evidence Project %NBS results of six assessed buildings

For the six buildings assessed in Phase One, there was **no substantive difference in %NBS ratings** between the Red Book and Yellow Chapter. For three buildings, the final %NBS rating did not change between Red Book and Yellow Chapter. For the other three buildings, there were some minor gains or losses in either direction: two went up and one went down using the Yellow Chapter.

- One building, coded as C1, was below 34%NBS under the Red Chapter and had this status changed under the Yellow Chapter (from 30%NBS to 50%NBS).
- One building, coded as A1, was marginally over 34%NBS under the Red Book and fell below this threshold under the Yellow Chapter (from 35%NBS to 25%NBS).
