## Determination 2008/55

### Refusal to issue a code compliance certificate due to concerns about the dark colour, and hence the durability, of the cladding to a new house at 38 Davies Drive, Nelson

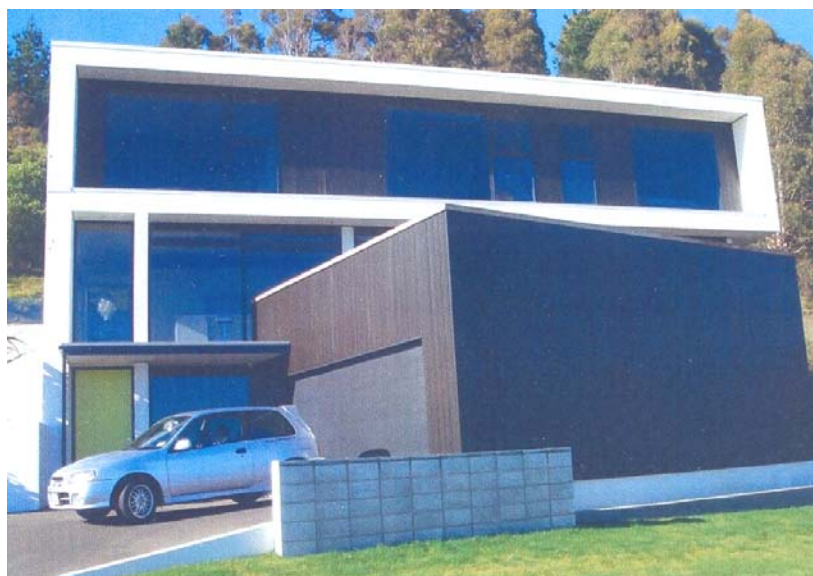
- 2.1 The building consists of a new 2-storey detached house situated on an excavated sloping site. The house walls are partially clad with cedar weatherboards.
- 2.2 The cedar cladding consists of 165mm vertical shiplap weatherboards, with an exposed face of about 140mm in width. The weatherboards are installed over 6mm fibre-cement “Eterpan” sheets, which are fixed over a “ventclad” 20mm drained cavity system to the framing over the building wrap. The cavity battens are H3.2 treated and are castellated on both sides in order to provide drainage to the horizontal battens that allow for sheet fixing. The cedar cladding has been finished with a black oil stain.
