Determination 2009/85

Determination regarding the refusal to issue a code compliance certificate for a 5-year-old block of four semi-detached townhouses at 11, 13, 15, & 17 Duxfield Drive, Waitakere City

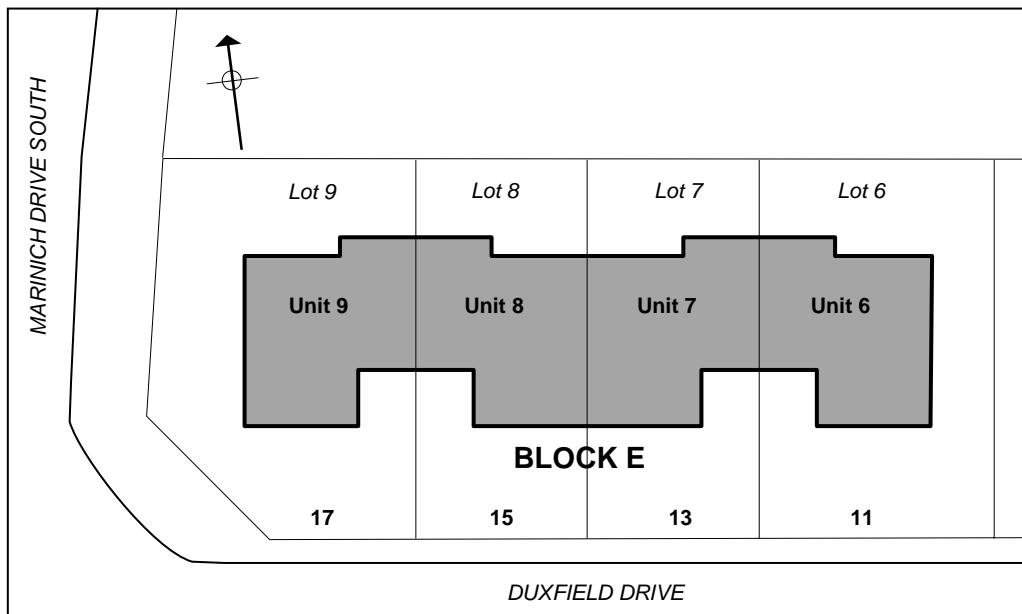
3.1 The following site plan shows Block E:
