Determination 2009/106

Determination regarding the refusal to issue a code compliance certificate for a 6-year-old block of 3 semi-detached townhouses at 2, 4 and 6 Kora Avenue, Waitakere City

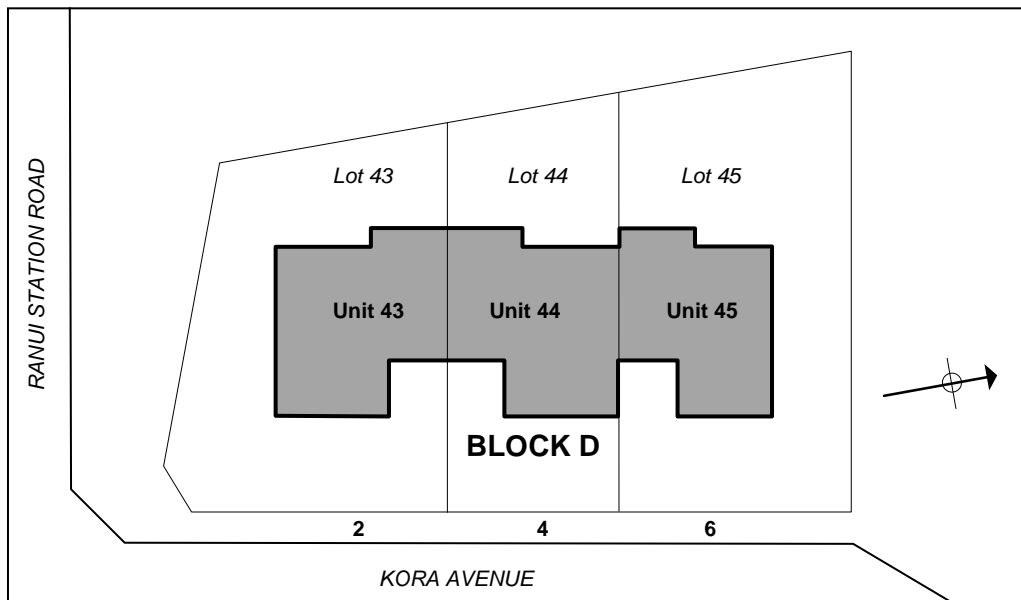
3.1 The following site plan shows Block D:

3.2 Block D is a two storey building, which is situated on a gently sloping site in a low wind zone in terms of NZS 3604². The block sits at the corner of Korā Avenue, with the main entries and garage doors facing east towards the road. The building is fairly
