## Determination 2010/051

### Refusal to issue a code compliance certificate for a 10-year-old house with monolithic cladding at 3/134 Birkenhead Avenue, North Shore

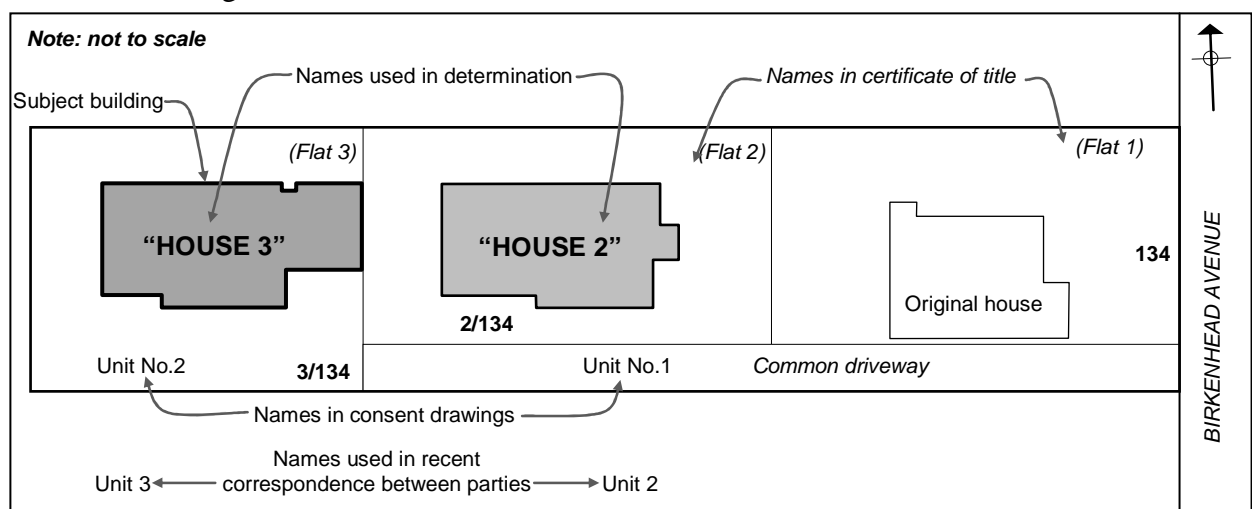
2.1 House 3 is one of three houses situated on a steep west-sloping site as shown in the following sketch:

- 2.2 The original property was long and narrow, with an existing 1920's house positioned towards the street at the eastern end. The property was initially sub-divided in 1991 by the then owner to provide two vacant crosslease sections behind the existing house. Each individual house has its own separate land and building title, which defines legal boundaries of the sections.
- 2.3 House 2 and House 3 were constructed on the two rear sections, with the building work for both houses carried out during 1999 and 2000 under a single building consent. Access to House 3 is provided by a shared steep driveway from the street.
