## Determination 2011/101

### The refusal to issue a certificate of acceptance for 8-year-old cladding repairs carried out without a building consent to a semi-detached townhouse at 3/9 Pannill Place, Albany

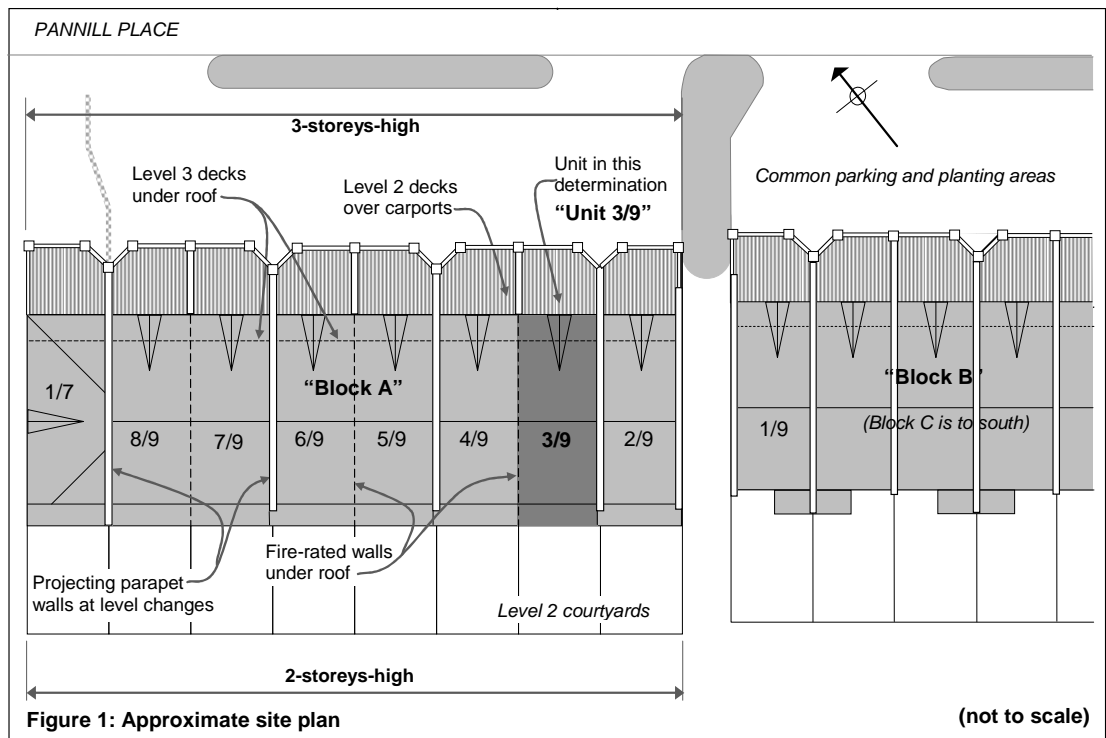
2.3 Block A contains eight separately-titled units and steps down the slope parallel to the road as shown in the site plan sketch in the figure below.

- 2.1 Unit 3/9 is one of eight units ("the units") within a free-standing building ("Block A"). Block A is a long two-storey building with basements situated on a north-sloping site in a medium wind zone for the purposes of NZS 3604<sup>5</sup>. It is part of a larger development comprising 22 units in three similar blocks of terrace housing ("the development").
- 2.2 Construction of Block A is generally conventional light timber frame, with concrete slabs, concrete block foundations and retaining walls, timber-framed upper floors, concrete tile gable roofing, monolithic wall cladding and aluminium windows. The building as a whole is fairly complex in plan and form and is assessed as having a high weathertightness risk.
