Determination 2017/010

The refusal to issue code compliance certificates for a 21-year-old house with 9-year-old alterations and addition at 28 Christian Road, Swanson

This determination is concerned with the compliance of a house and alterations that are, respectively, 21 and 9 years old. The determination considers the authority's reasons for refusing the code compliance certificates, and whether the house currently complies with the requirements of the Building Code, particularly with respect to weathertightness and durability.

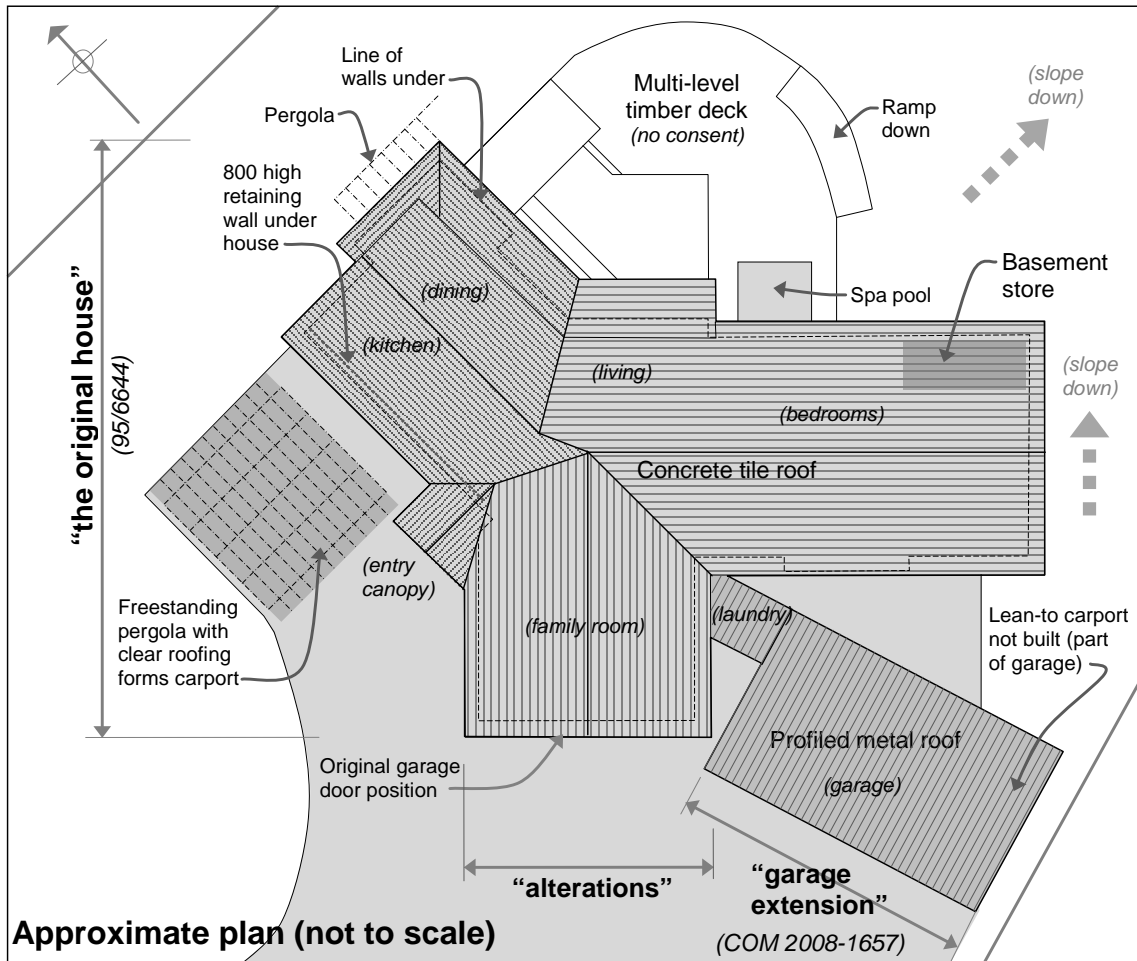
Figure 1: Approximate site plan

- 2.1 The building work considered in this determination is a single-storey detached extended house on a steeply sloping rural site in a low to medium wind zone for the purposes of NZS 3604⁸. Construction took place from 1995 as shown in Table 1.
- 2.2 The completed building is shown in Figure 1 and comprises:
- The original house: a single-storey house, with living areas to the north, a bedroom wing to the south east and a family room converted from the original garage area.
 - The garage extension: a single-storey extension to the south east, providing a garage/workshop building attached to the house with a laundry corridor.
 - A large multi-level deck to the north of the house.
