# Determination 2024/028

**Regarding the issue of a dangerous and affected building notice for a dwelling**

**311 Lakes Boulevard, Pyes Pa, Tauranga**

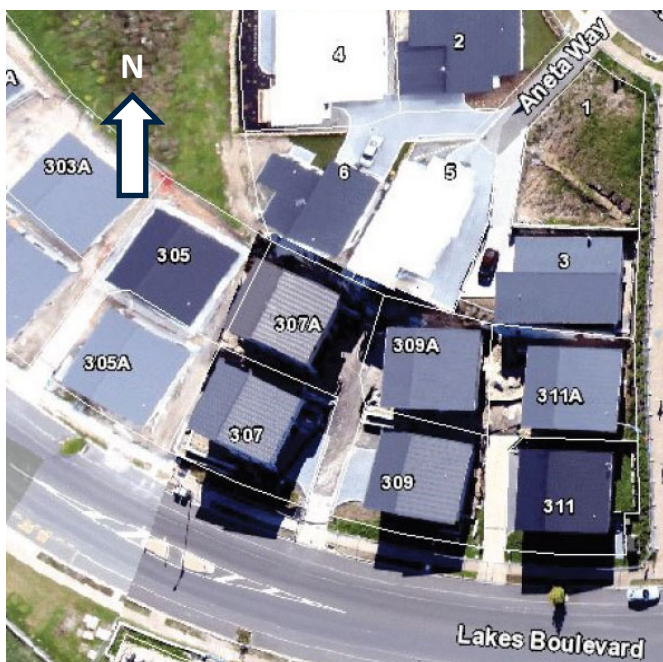
**Figure 1: Location of the property within the subdivision (before the dwellings were removed or demolished)**

- 2.1. The dwelling, which has now been demolished,<sup>12</sup> was located at 311 Lakes Boulevard (“the property”) in the Bella Vista subdivision (“the subdivision”), Pyes Pa, Tauranga. The subdivision included 16 dwellings on Lakes Boulevard (eight with road frontages and eight on rear sections) and five dwellings on higher ground at Aneta Way (refer to figure 1).
