Determination 2024/036

The proposed refusal to issue a code compliance certificate for a house

4B Kotare Road, Kaipara

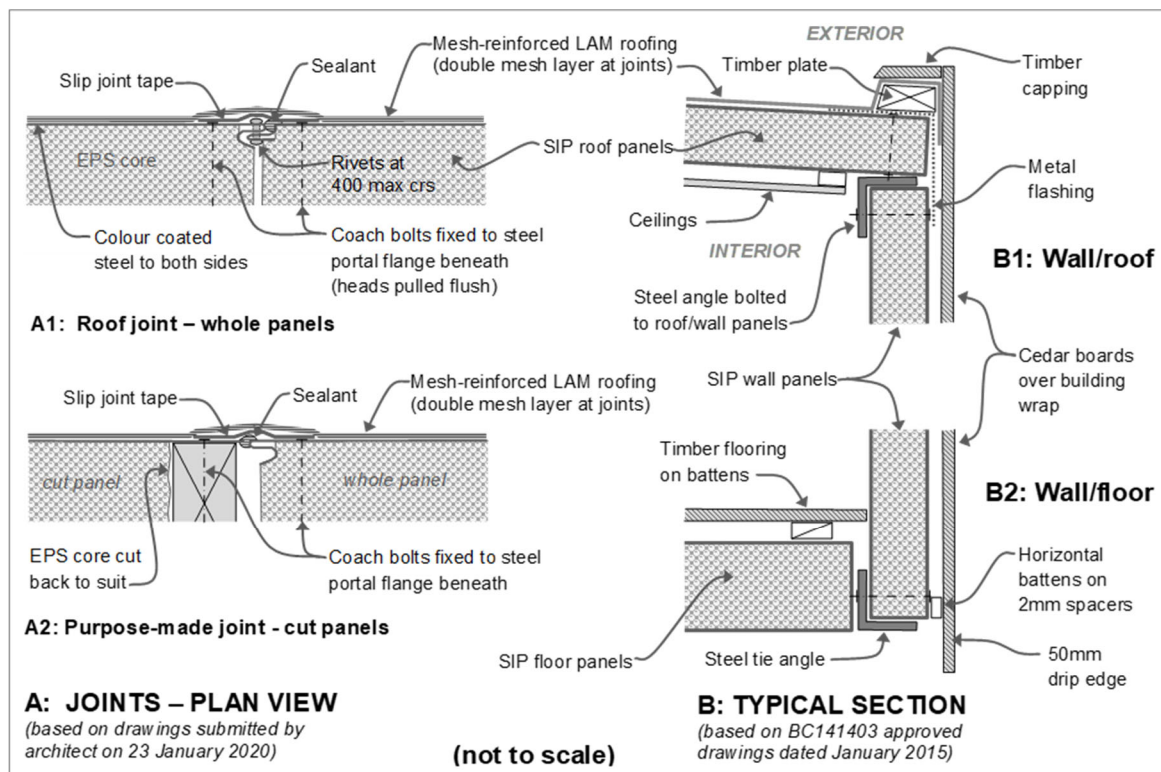
Figure 3: SIP construction

- 2.6. The SIP manufacturer and supplier (“the SIP supplier”) provides a variety of different insulated panels, with different profiles, cores and surfaces to suit different purposes. The 1200mm wide structural panels have a fire retardant treated expanded polystyrene (“EPS”) core with continuous colour-coated steel skins laminated over both sides and interlocked tongue-in-groove joints.
- 2.7. Based on details provided by the designer, Figure 3(A1) shows roof panels detailed by the designer, overlaid with liquid applied membrane (“LAM”) with slip joint tape at panel joints, and Figure 3(A2) shows cut panels with purpose-made joints.
